**Majdal Yābā:
The History and Material Culture of a Fortified Village in
Late Ottoman- and British Mandate-Palestine**

Tsvika Tsuk,¹ Iosi Bordowicz¹ and Itamar Taxel²

ONLINE SUPPLEMENT FIGURES

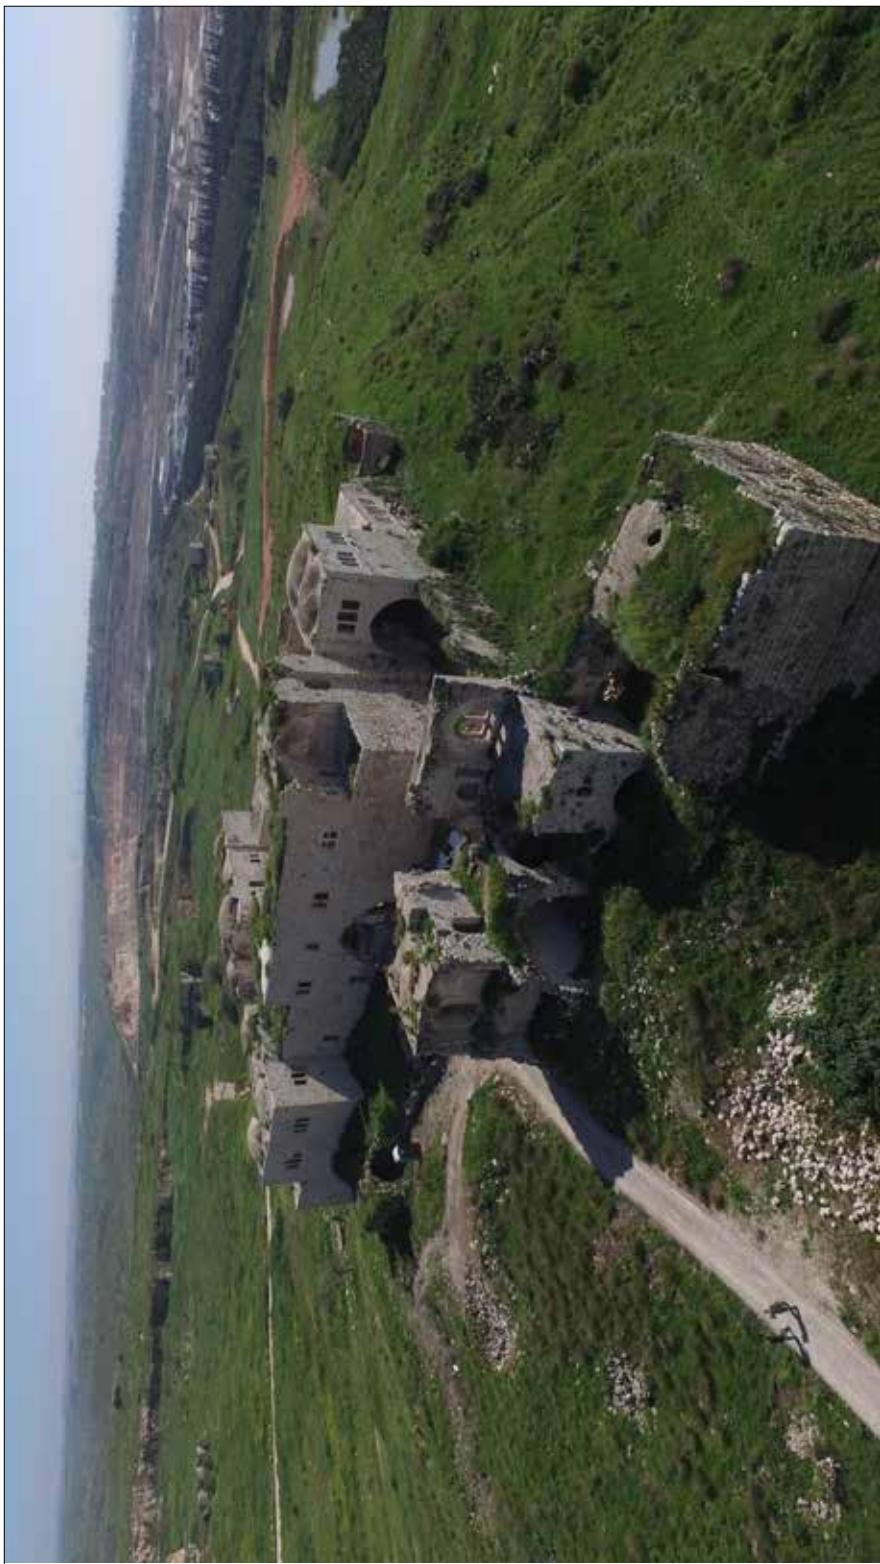
Figure 2 The Ottoman manor house built over the Crusader castle, looking southeast.

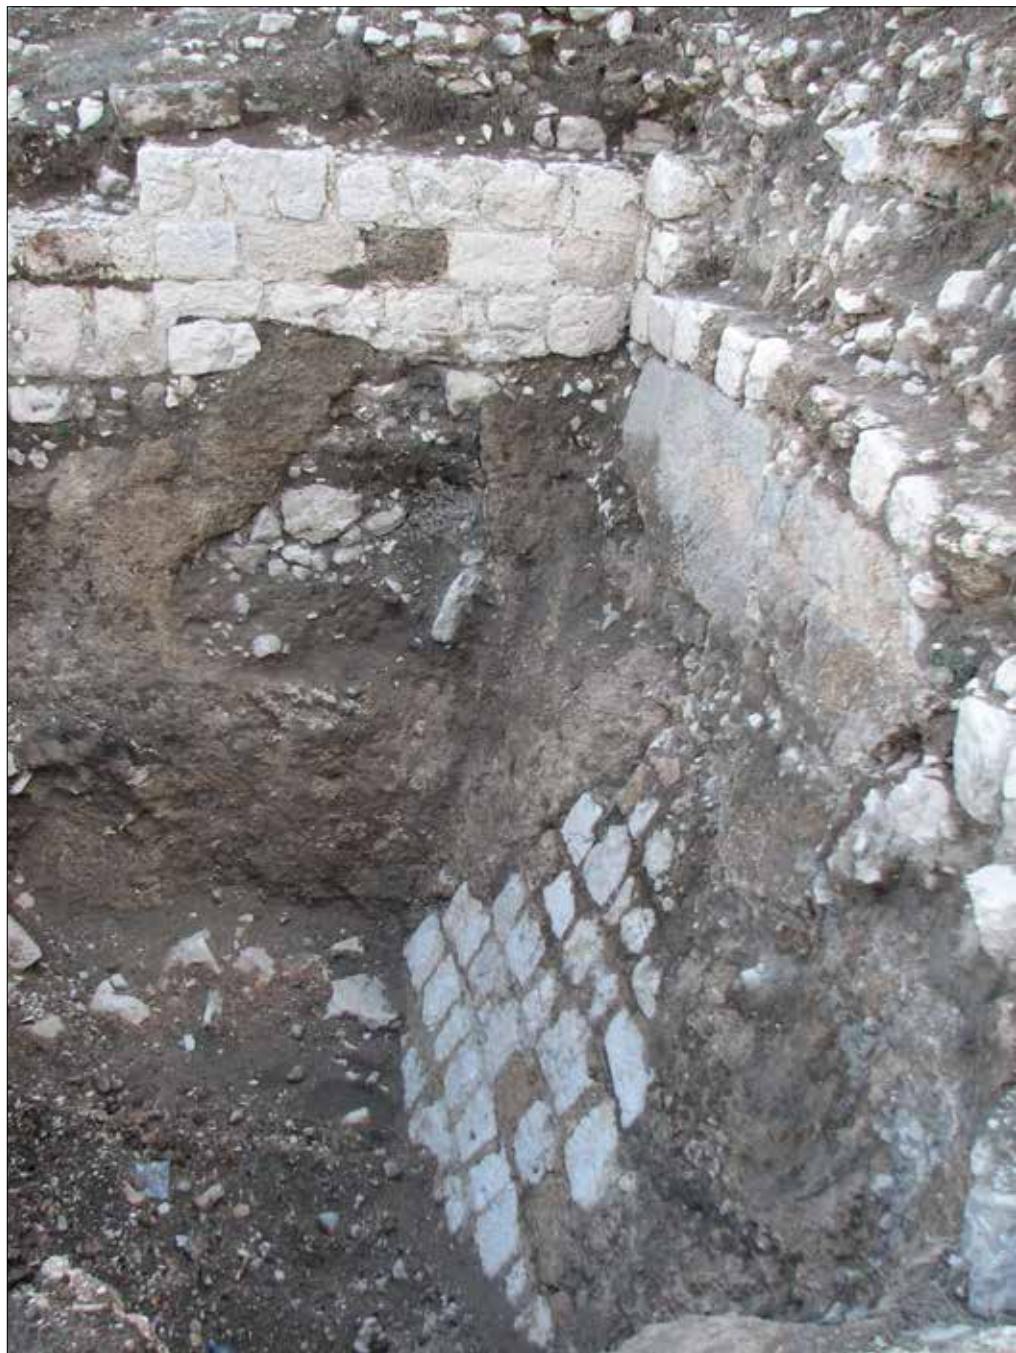
Figure 7 The Crusader moat, looking east.

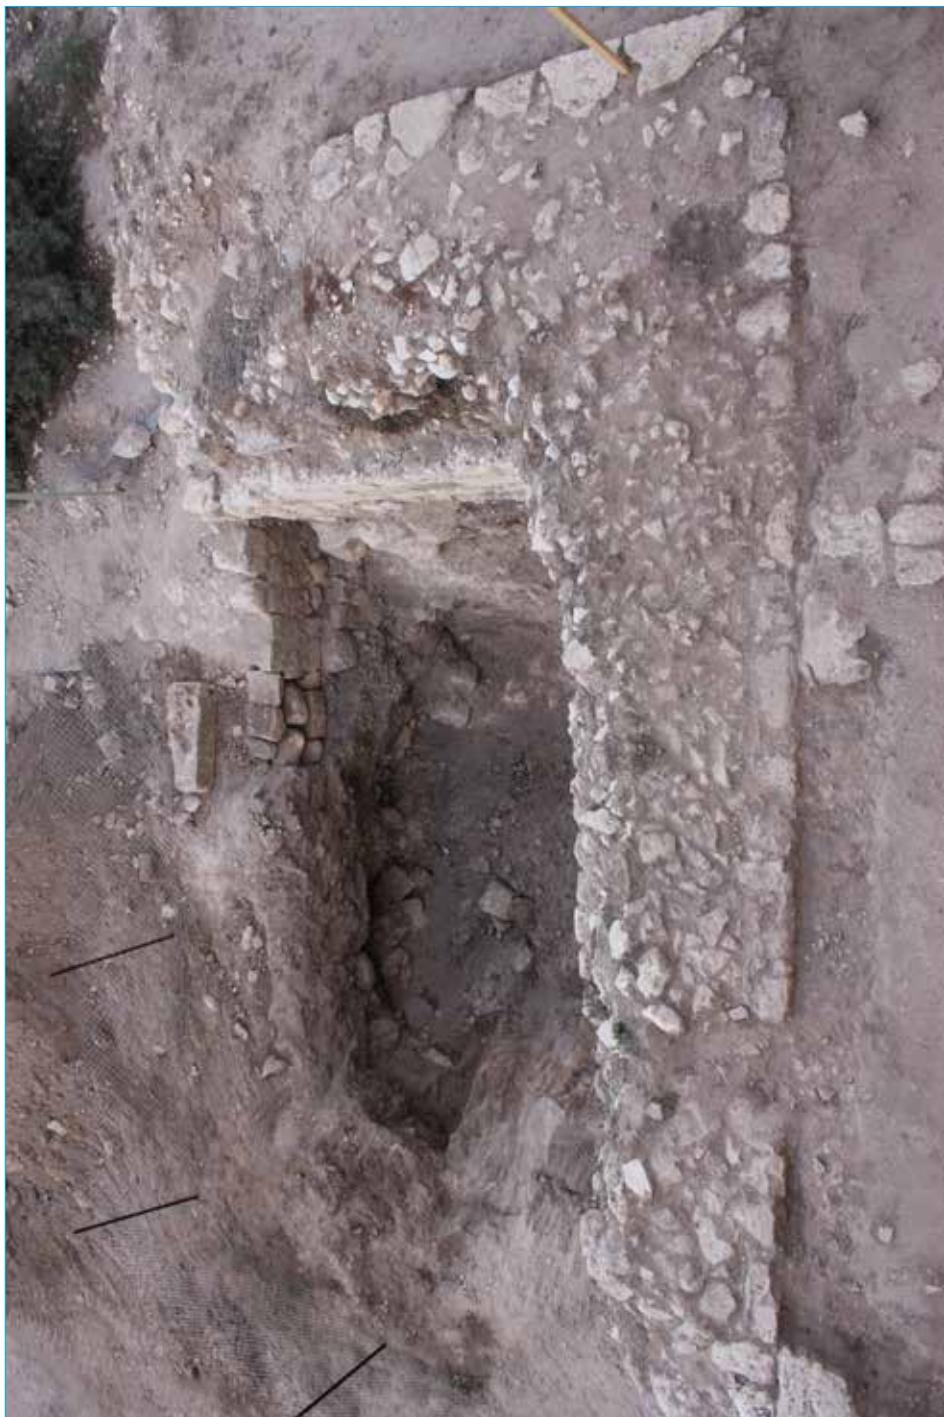
Figure 8 The Crusader moat, looking north.

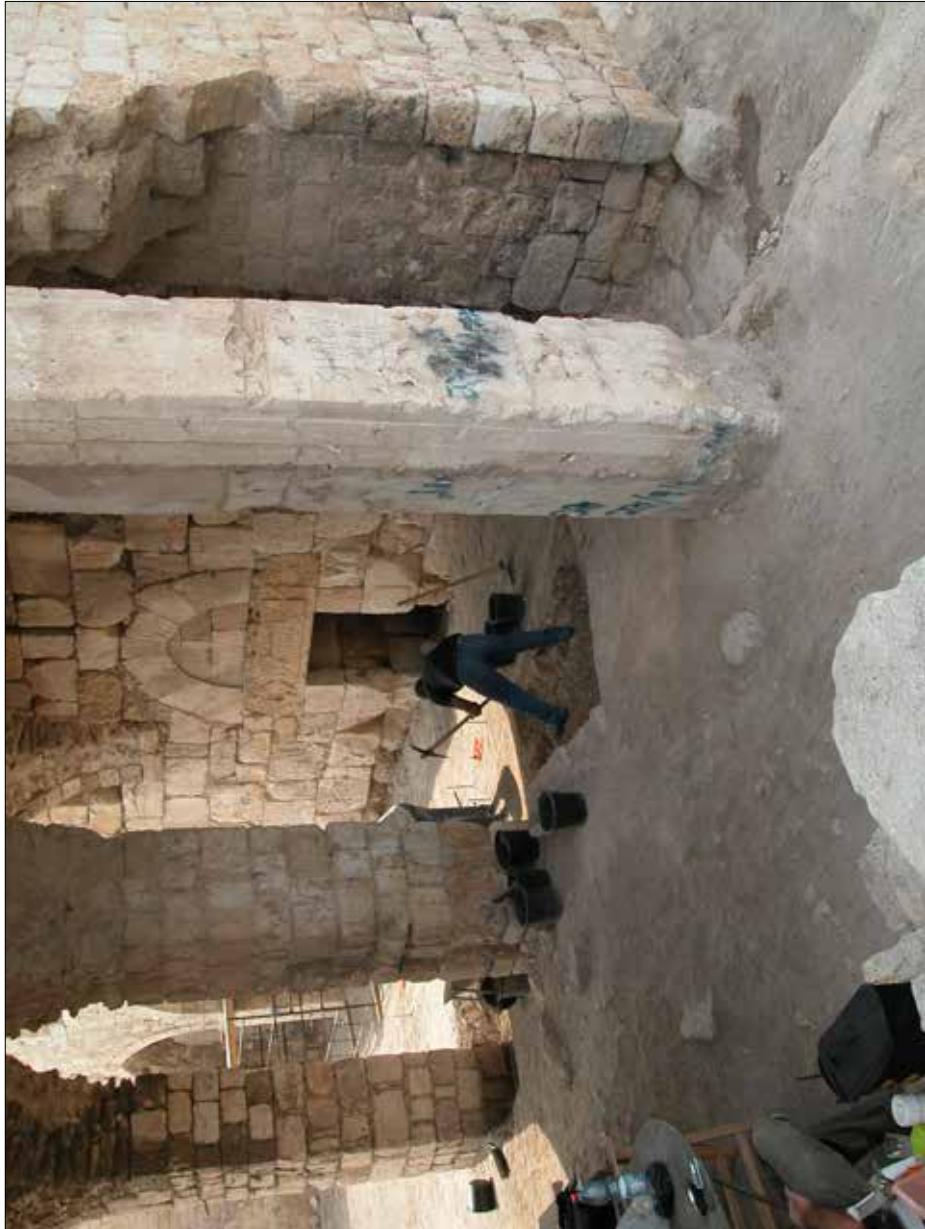
Figure 9 Remains of the main gate and Porticos 13-14, looking southwest.

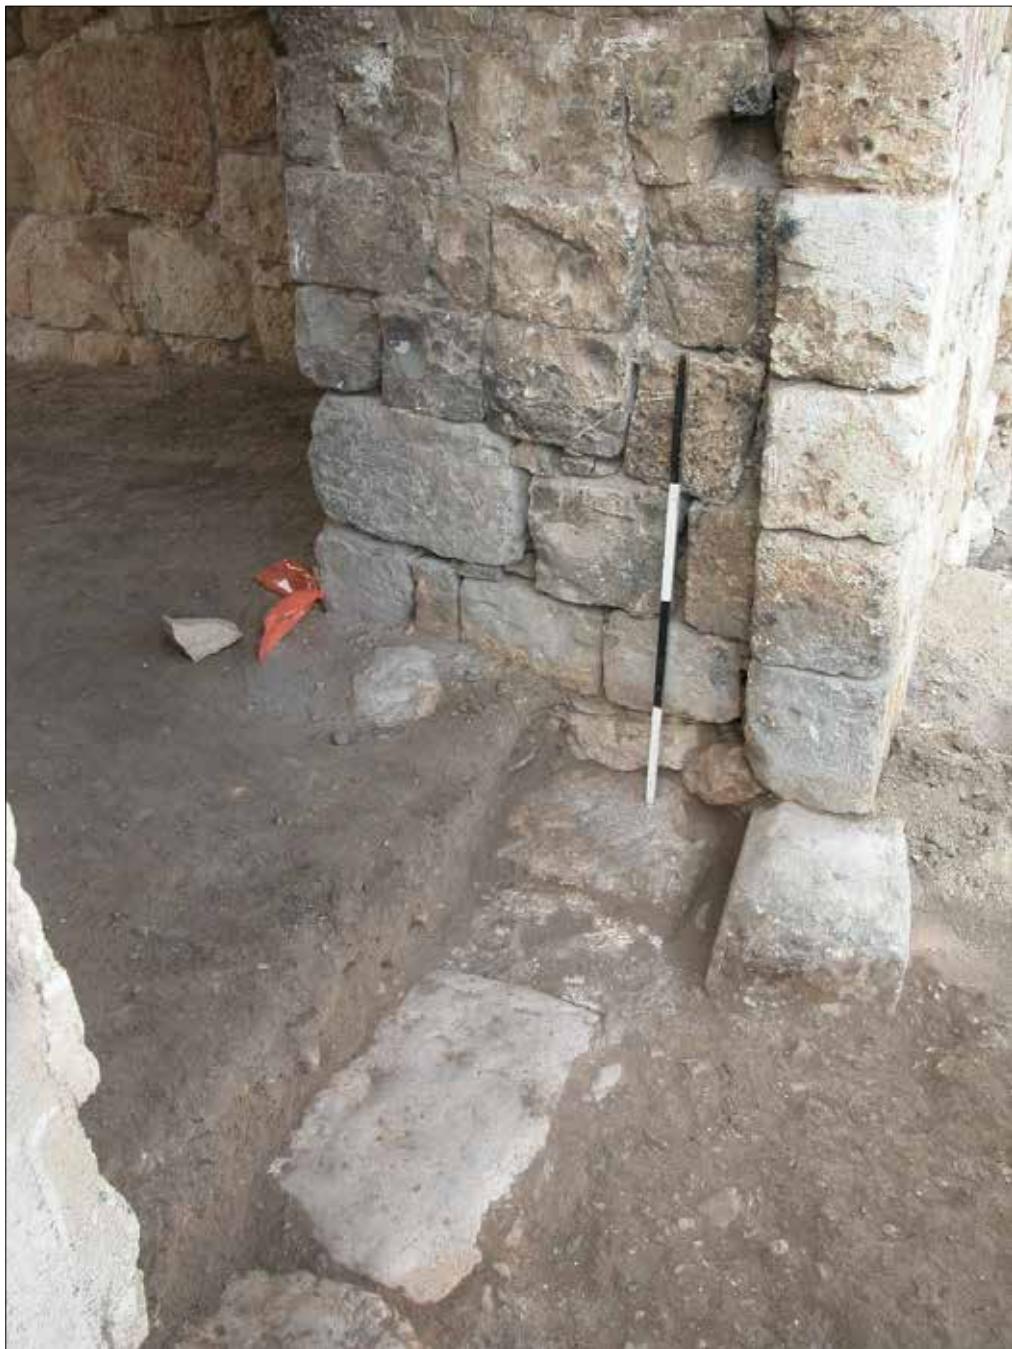
Figure 10 The threshold of the main gate.

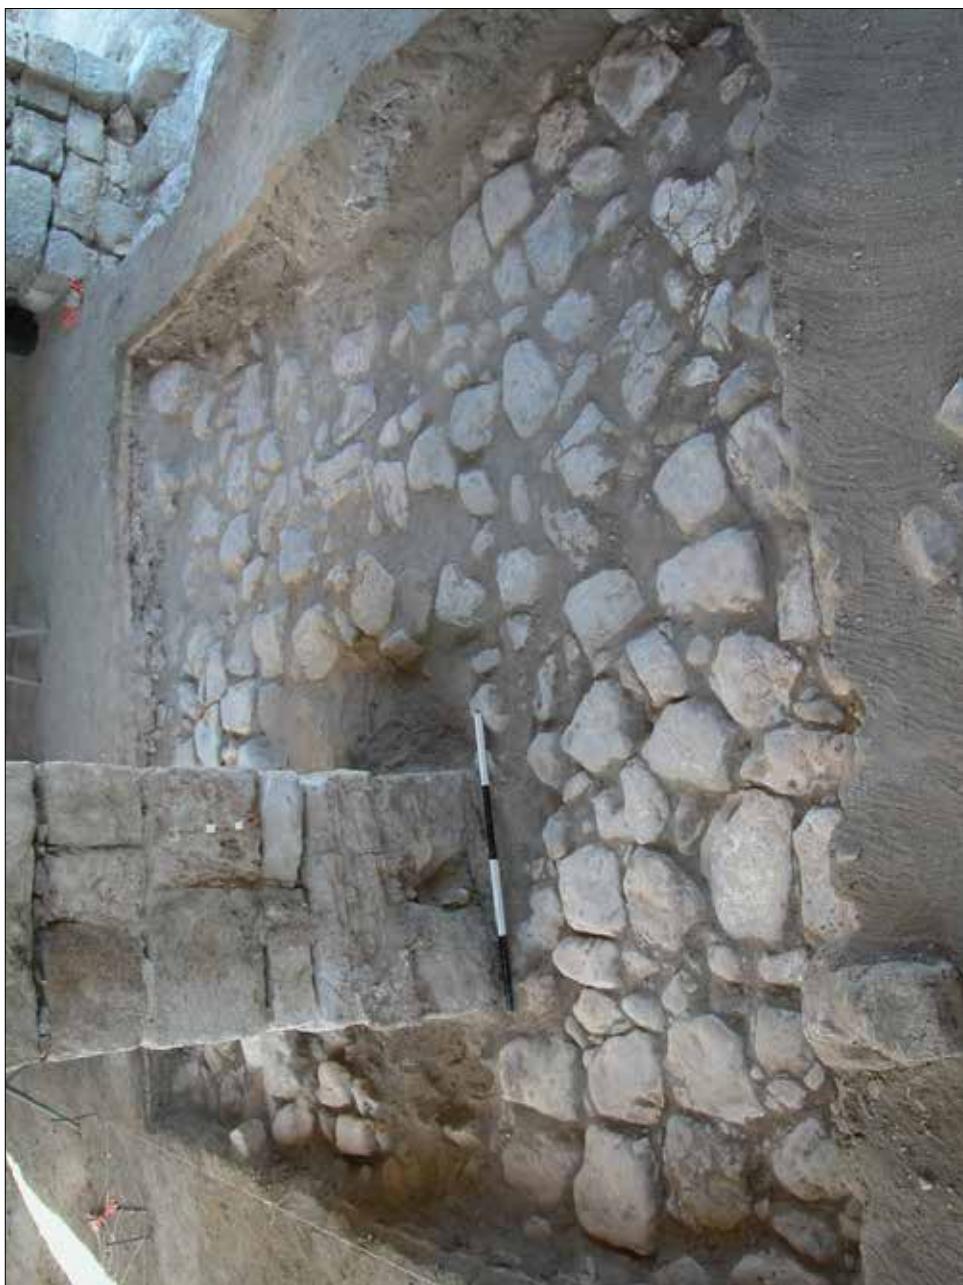
Figure 11 Stone pavement (Locus 102) in Porticos 13-14.

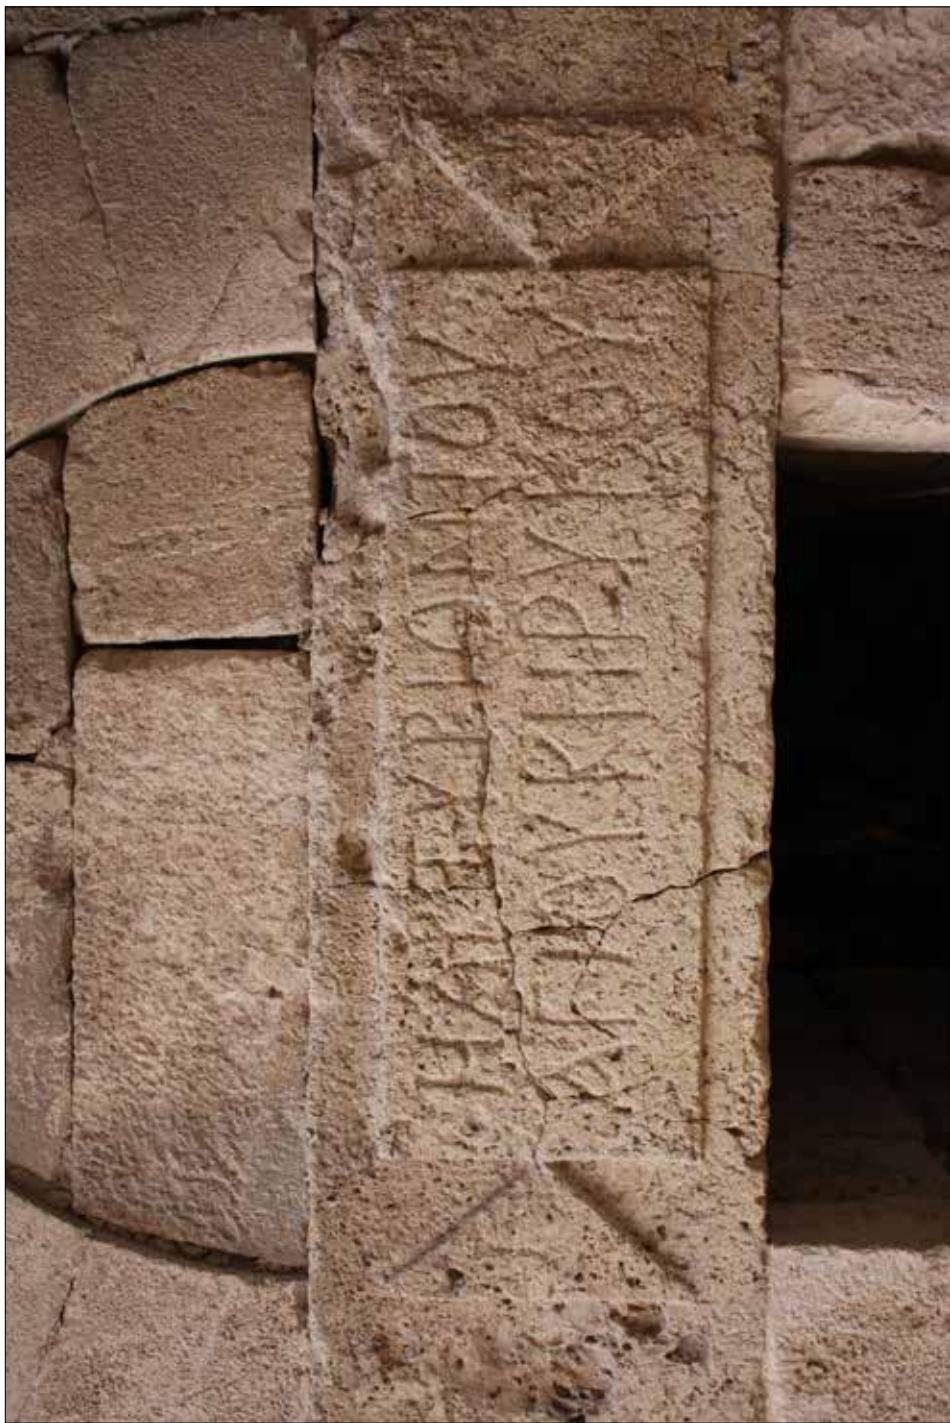
Figure 12 The Byzantine lintel bearing a Greek inscription in secondary use in the doorway of the Crusader tower/Room 18.

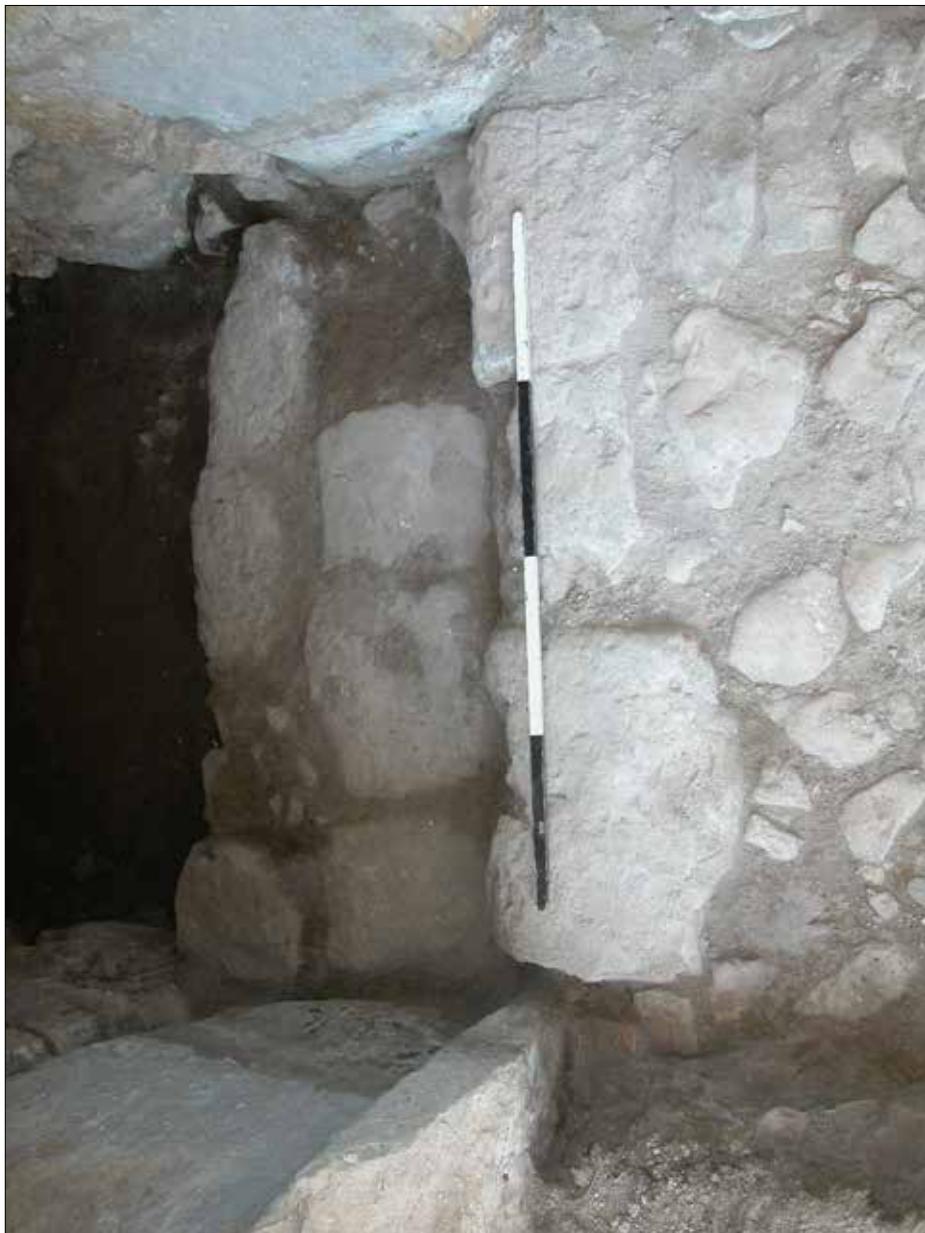
Figure 13 The threshold (Locus 108) of the doorway of the Crusader tower/Room 18.

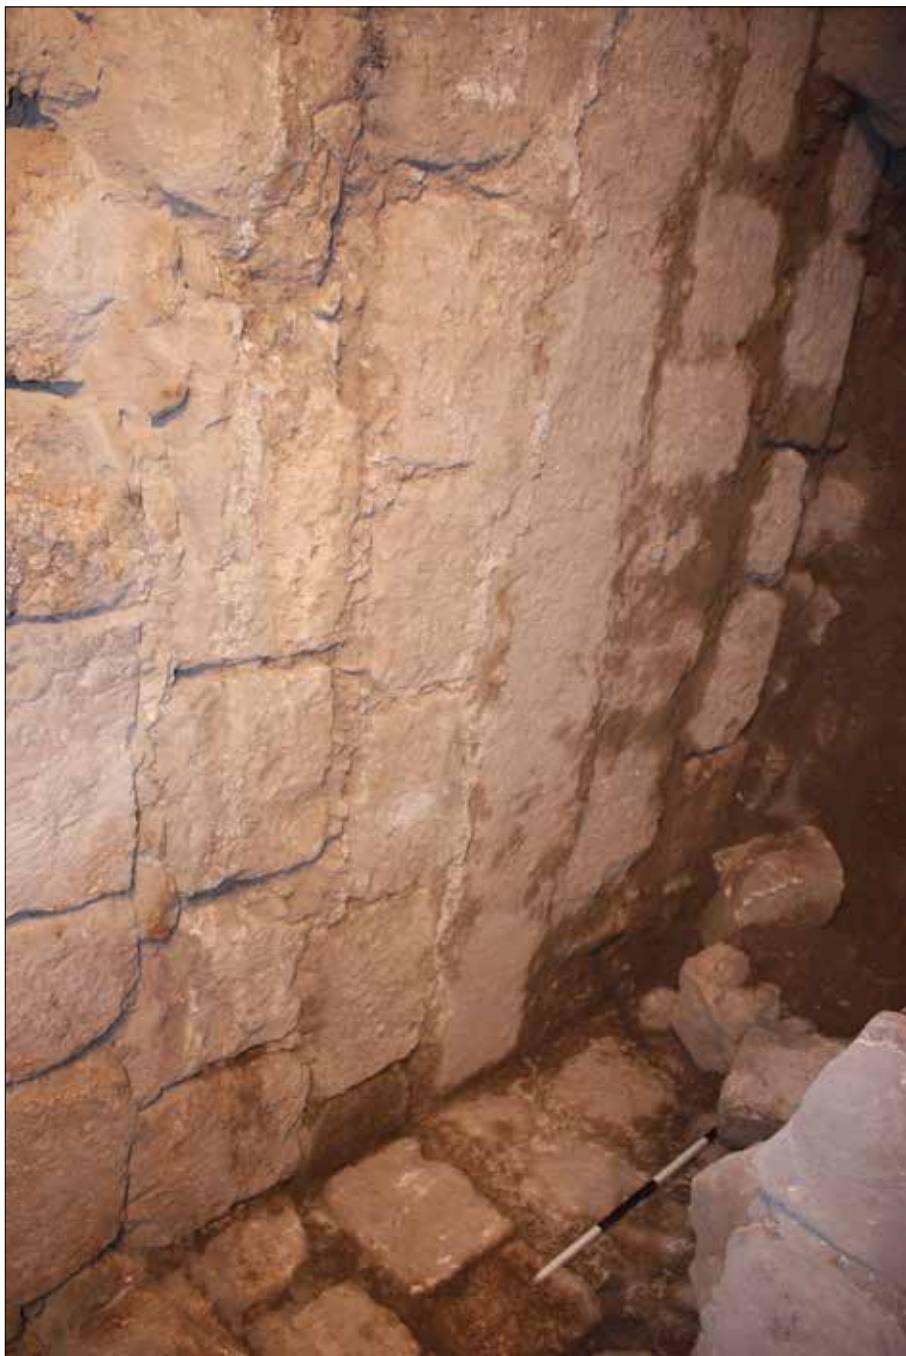
Figure 16 The section (Locus 200) at the northeastern corner of the Crusader tower/Room 18, looking east. Note the traces of two plaster floors, from the Crusader and Ottoman periods, on the rear wall.

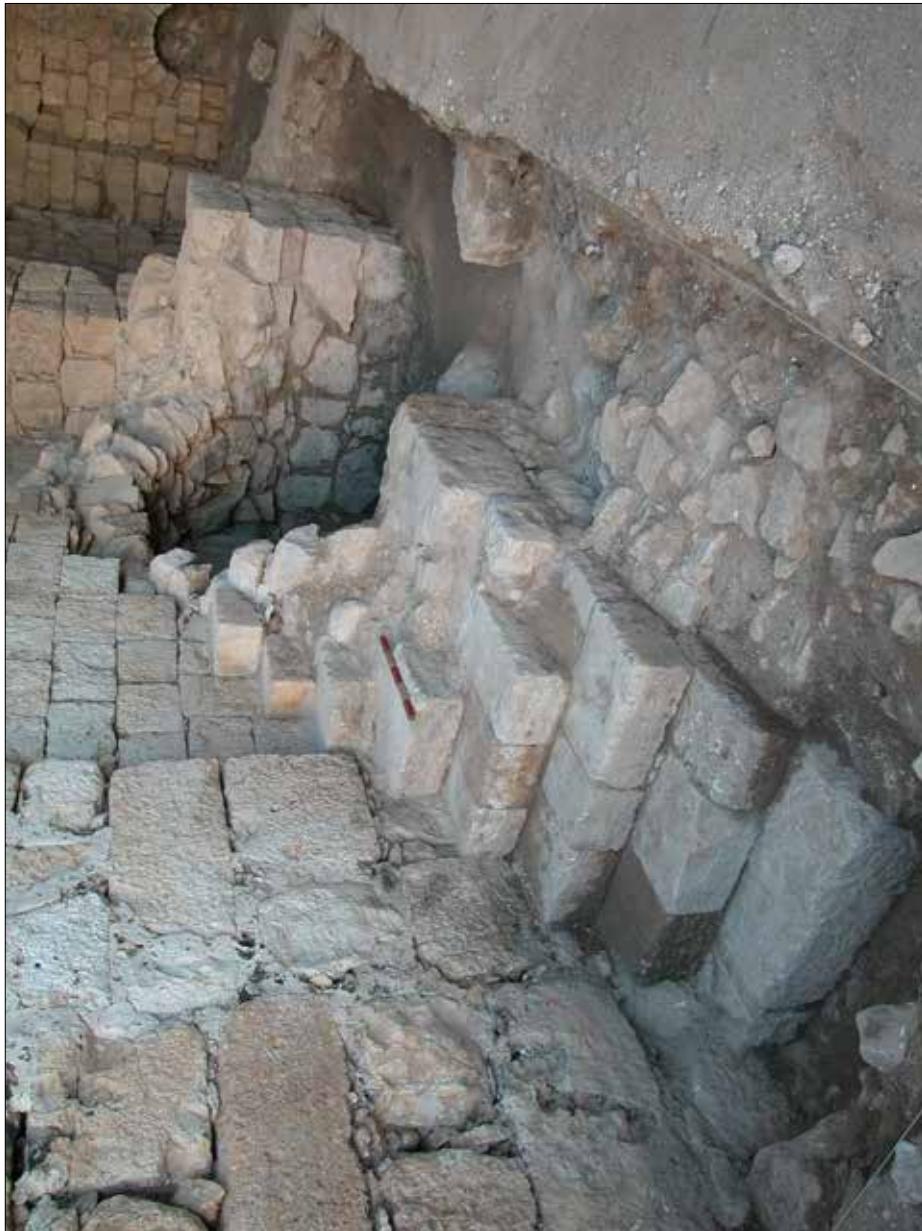
Figure 22 The staircase (Locus 114) in Room 23.

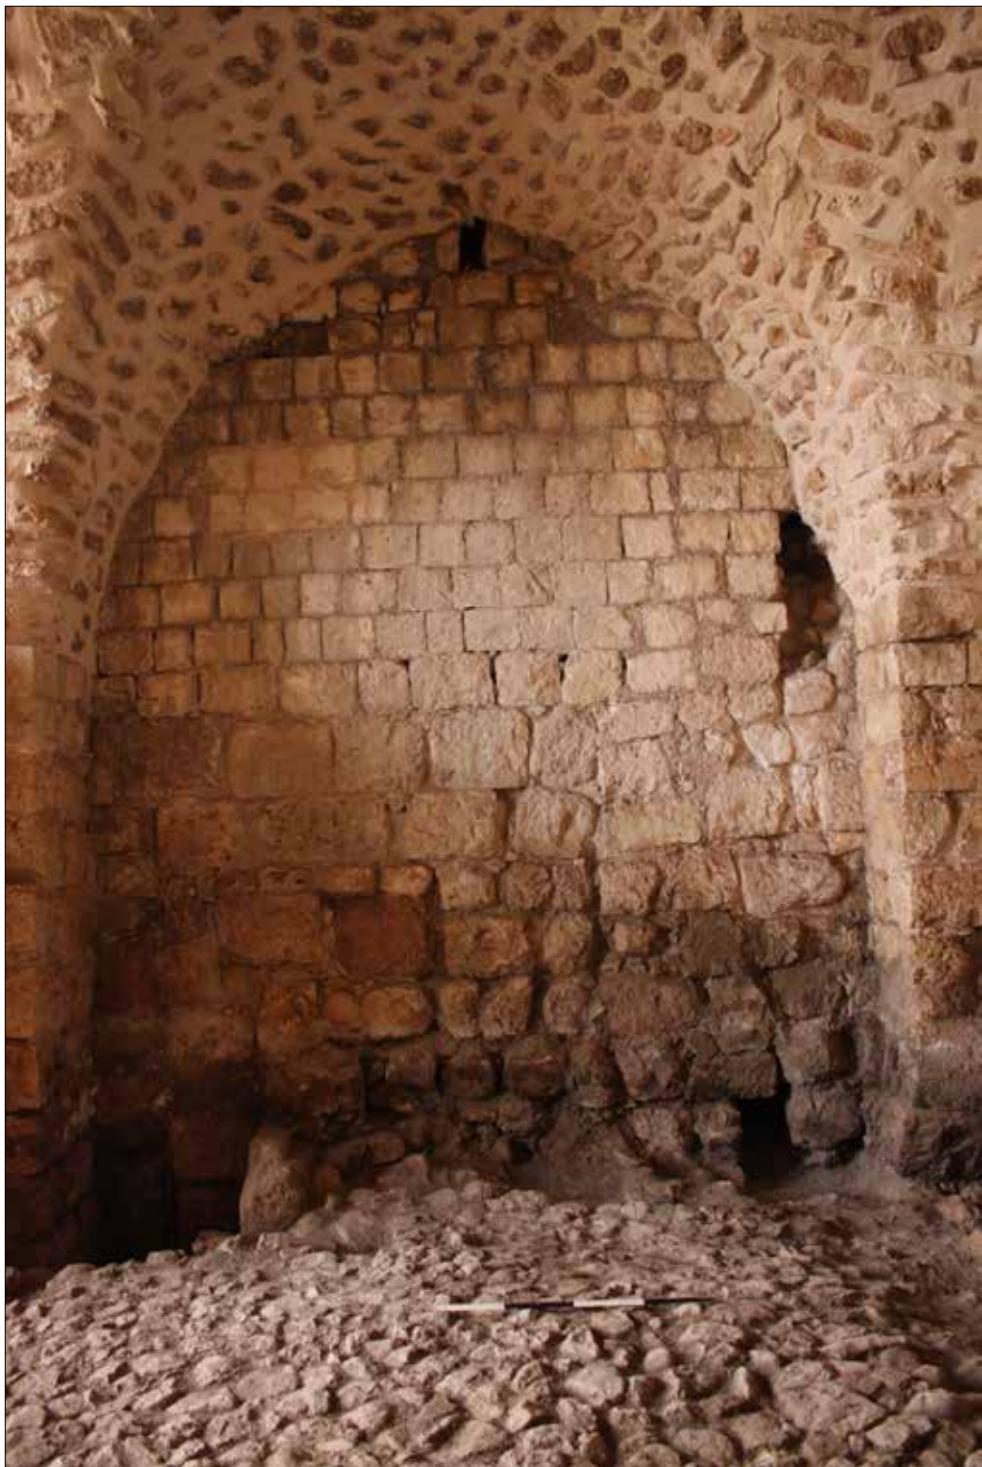
Figure 23 The eastern wall of Room 24, built over a Crusader wall with blocked doorway.
Note, on the upper right, the outlet of the toilets located on the second floor.

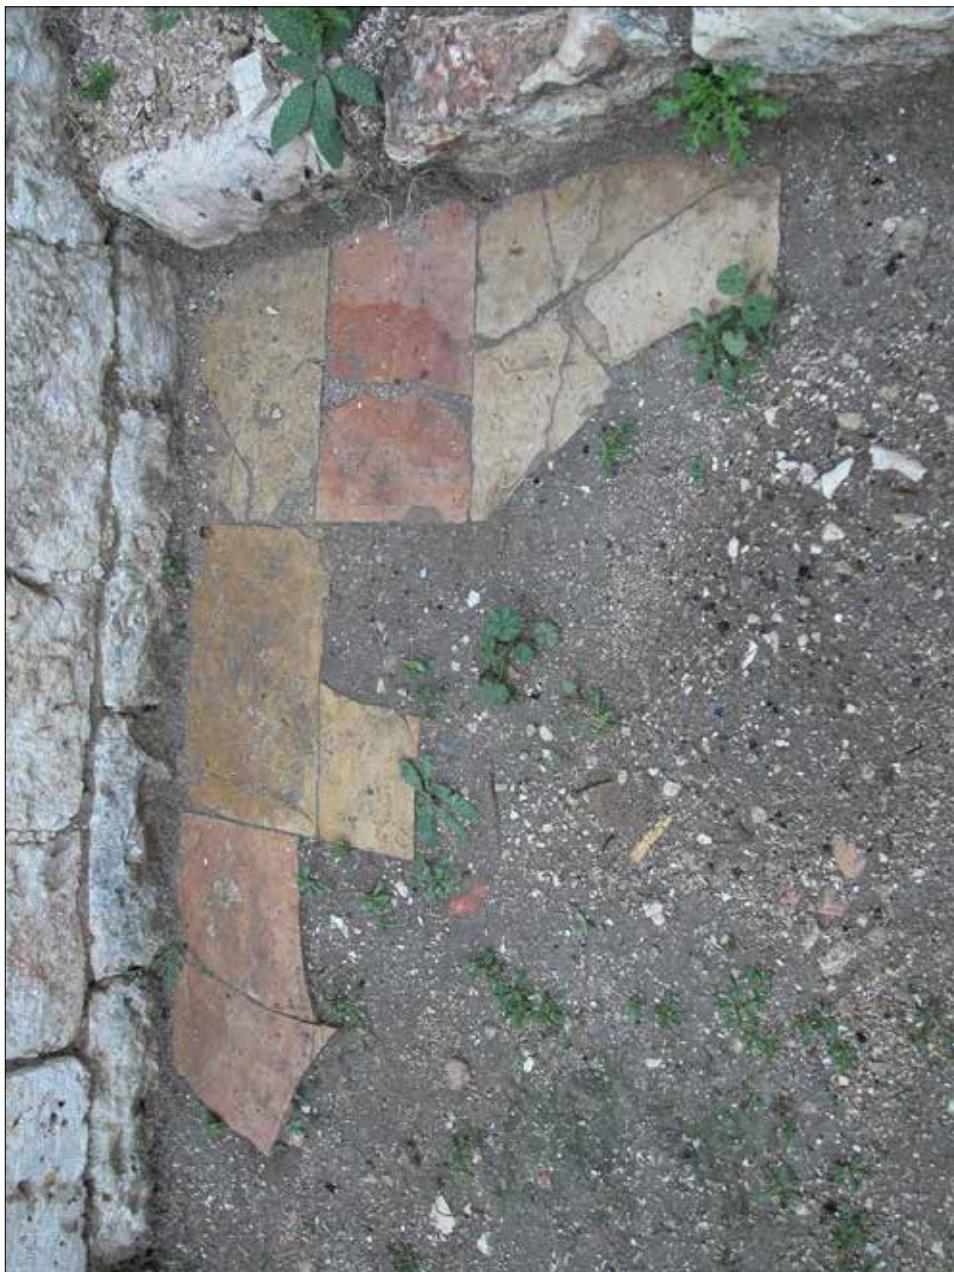
Figure 24 Limestone paving tiles at the northwestern corner of Courtyard 61.

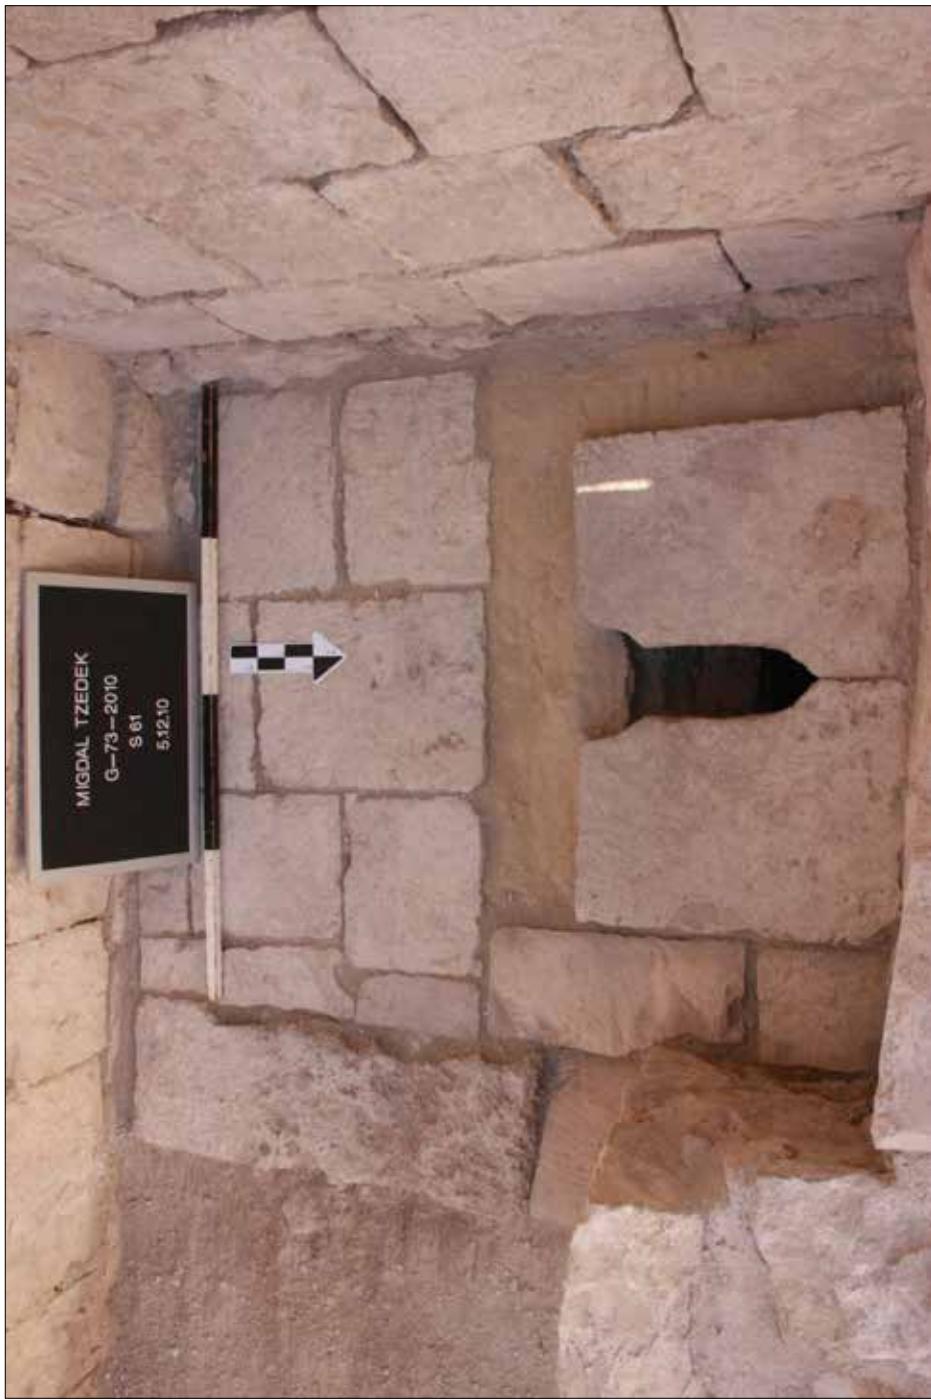
Figure 25 Toilet chamber 61A.

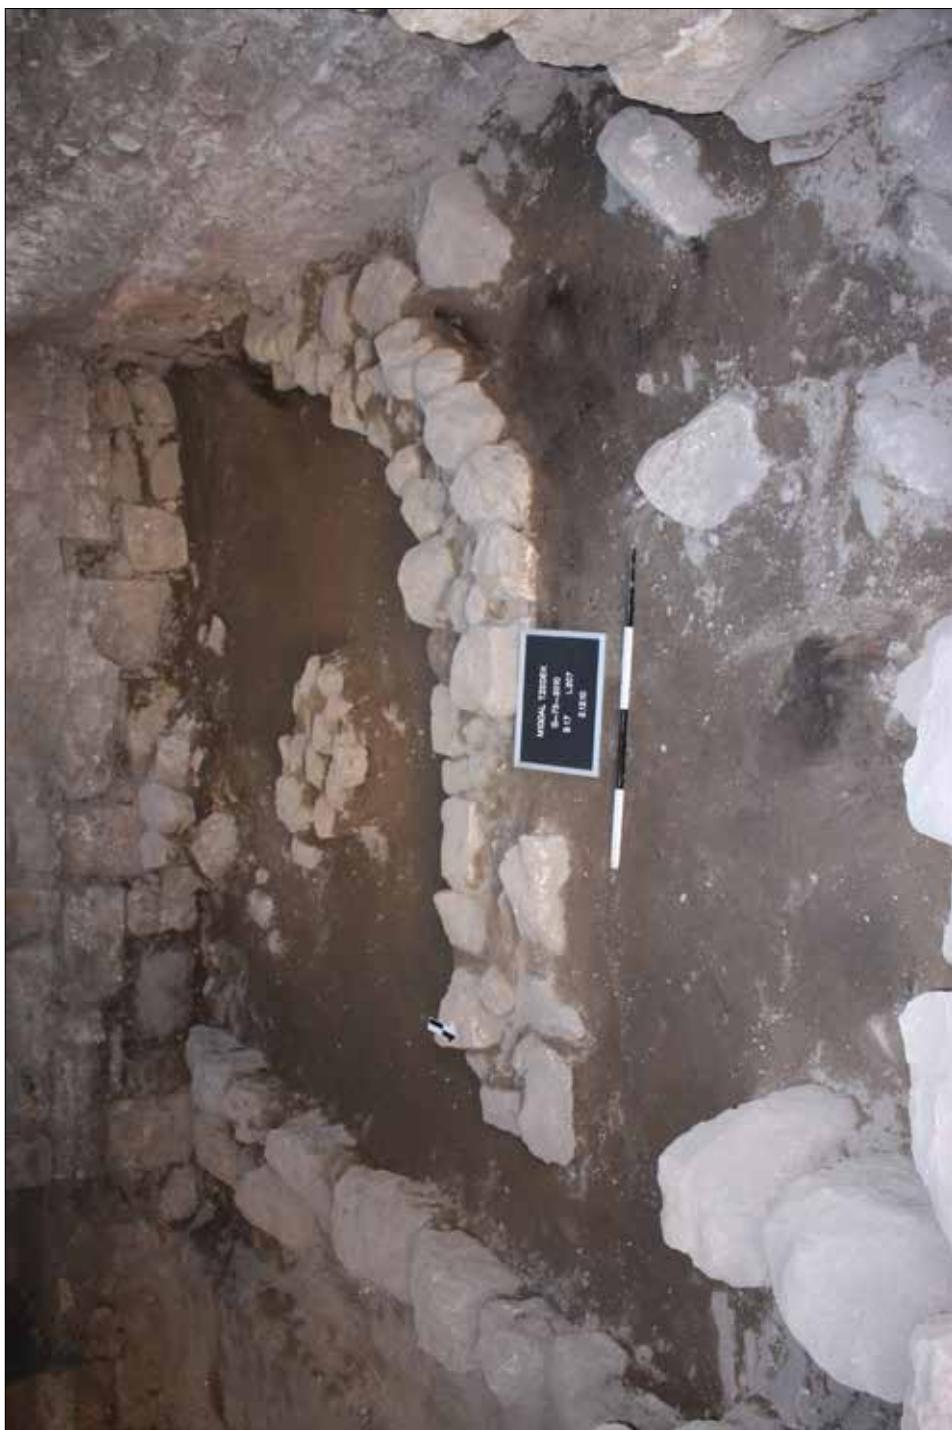
Figure 28 Walls 210 and 211 (on the left) in Room 17, looking south.

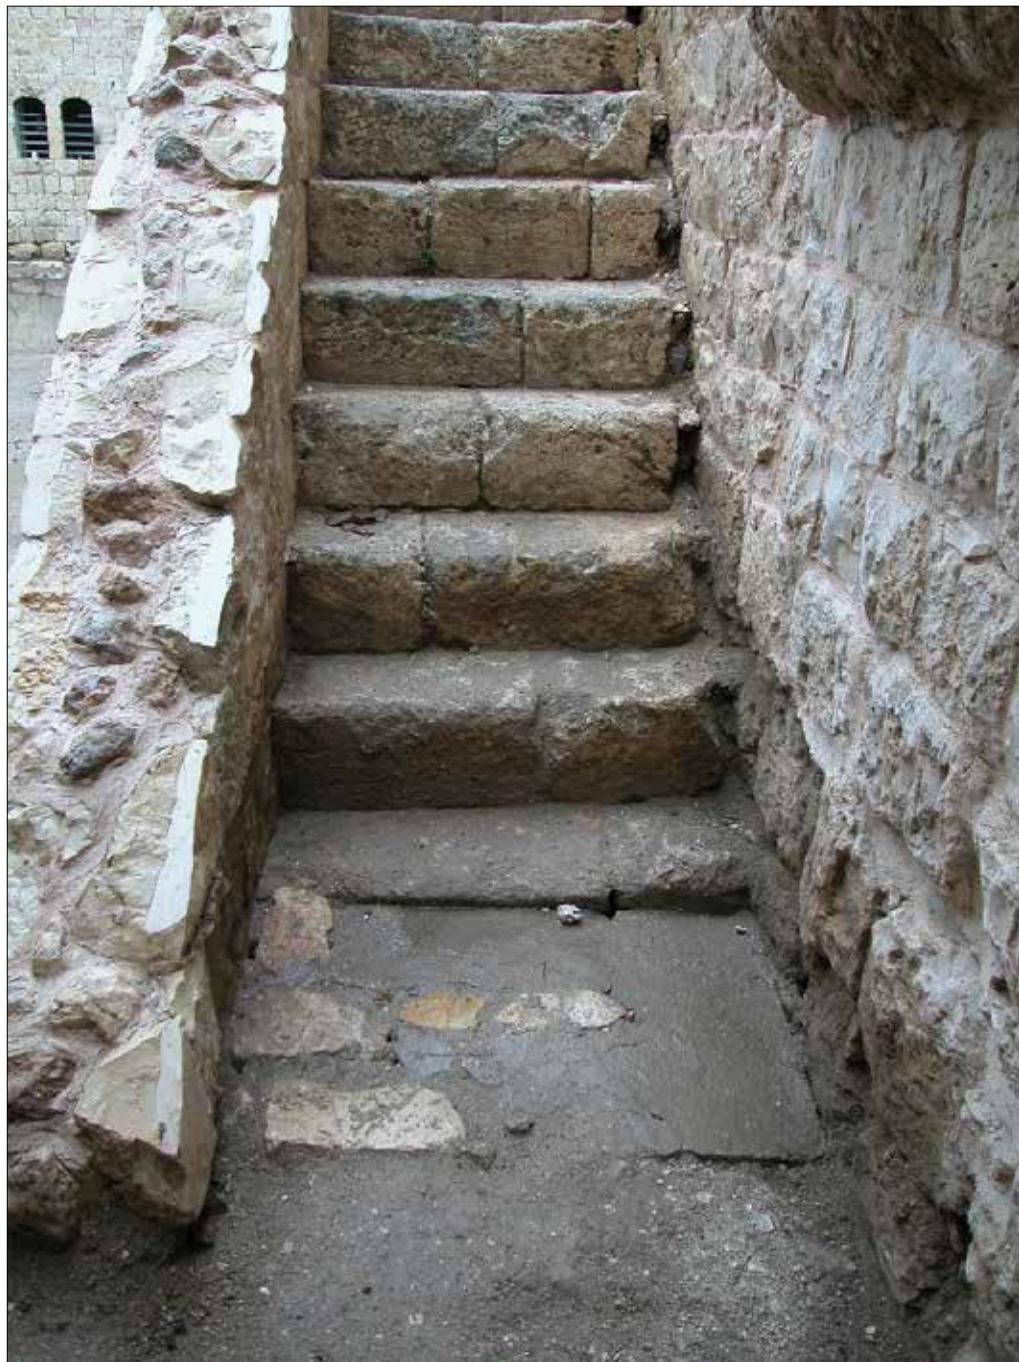
Figure 30 The staircase that lead from the main courtyard to Room/courtyard 55.

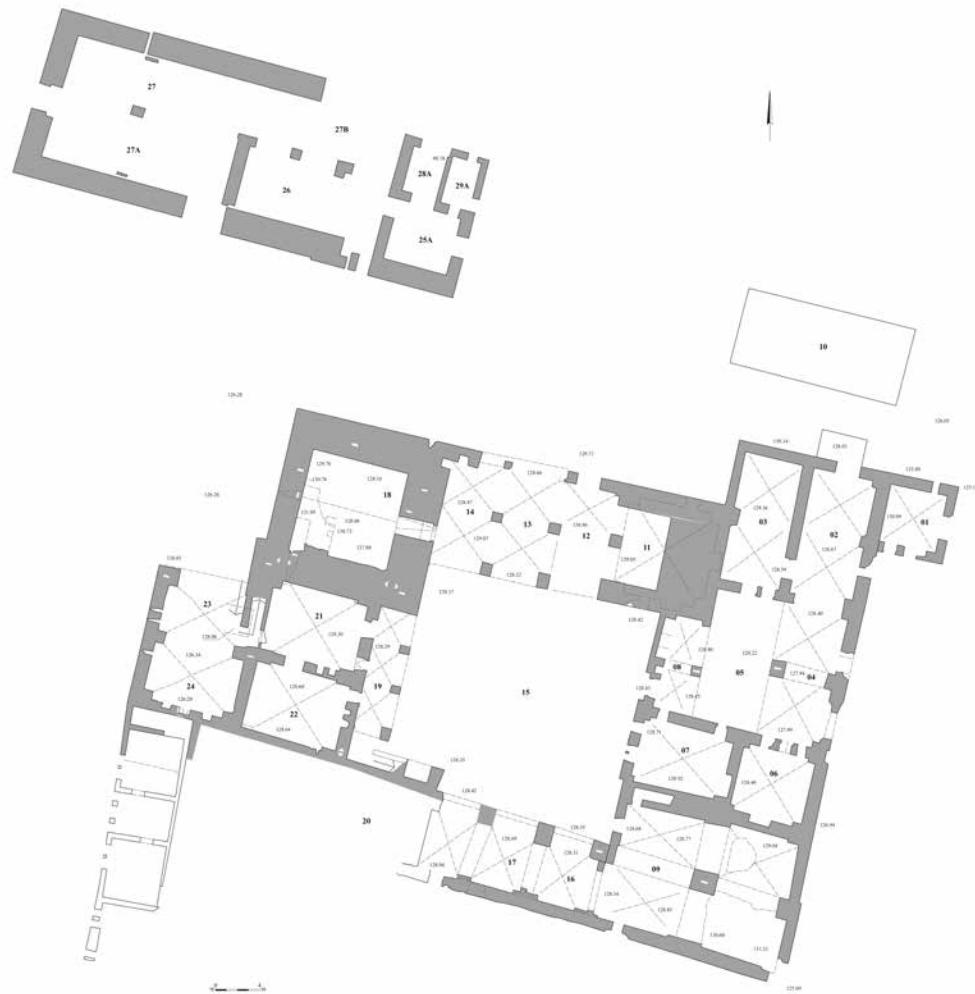
Plan 1 The manor house, ground floor (general plan).

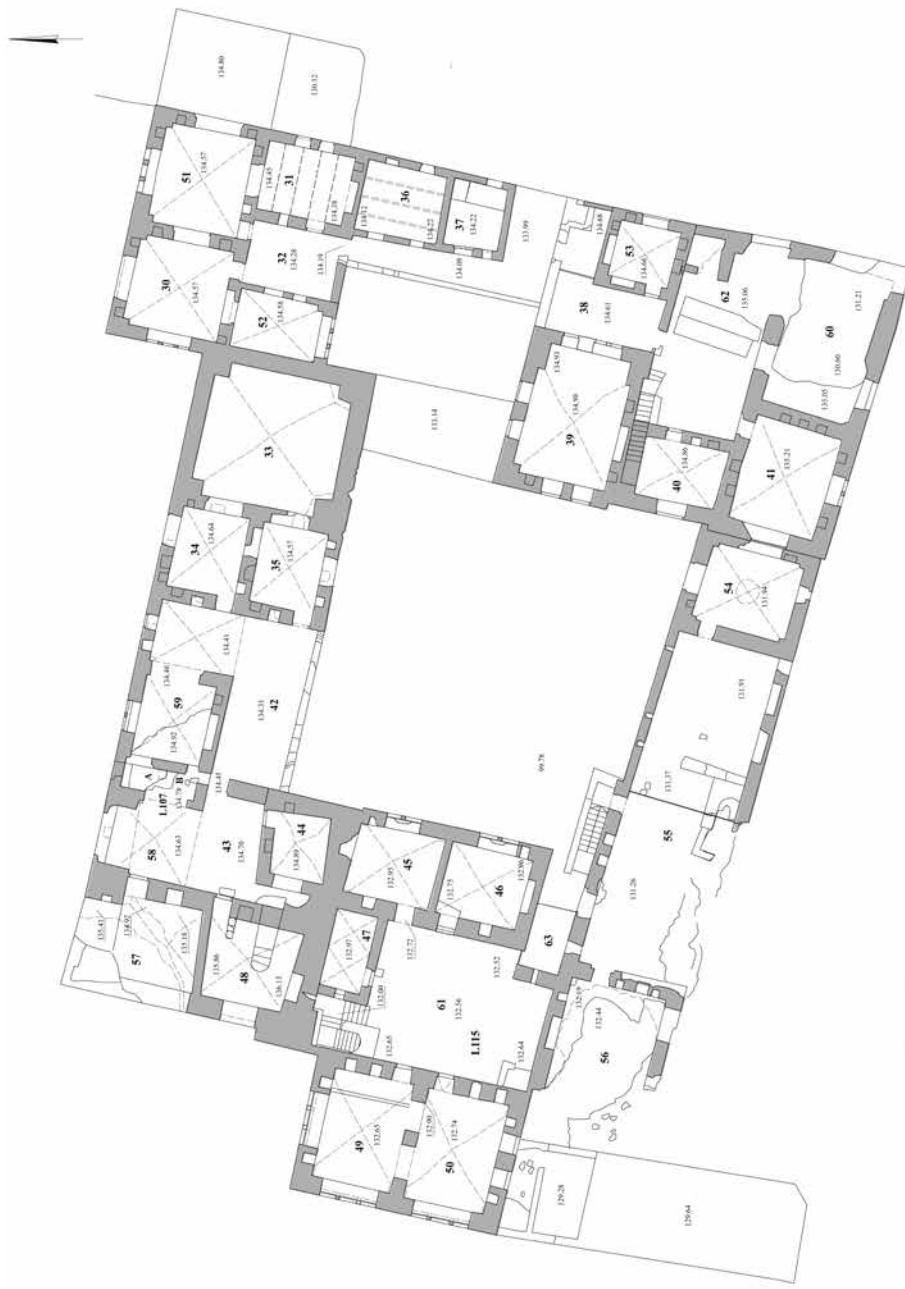
Plan 2

The manor house, second floor (general plan).

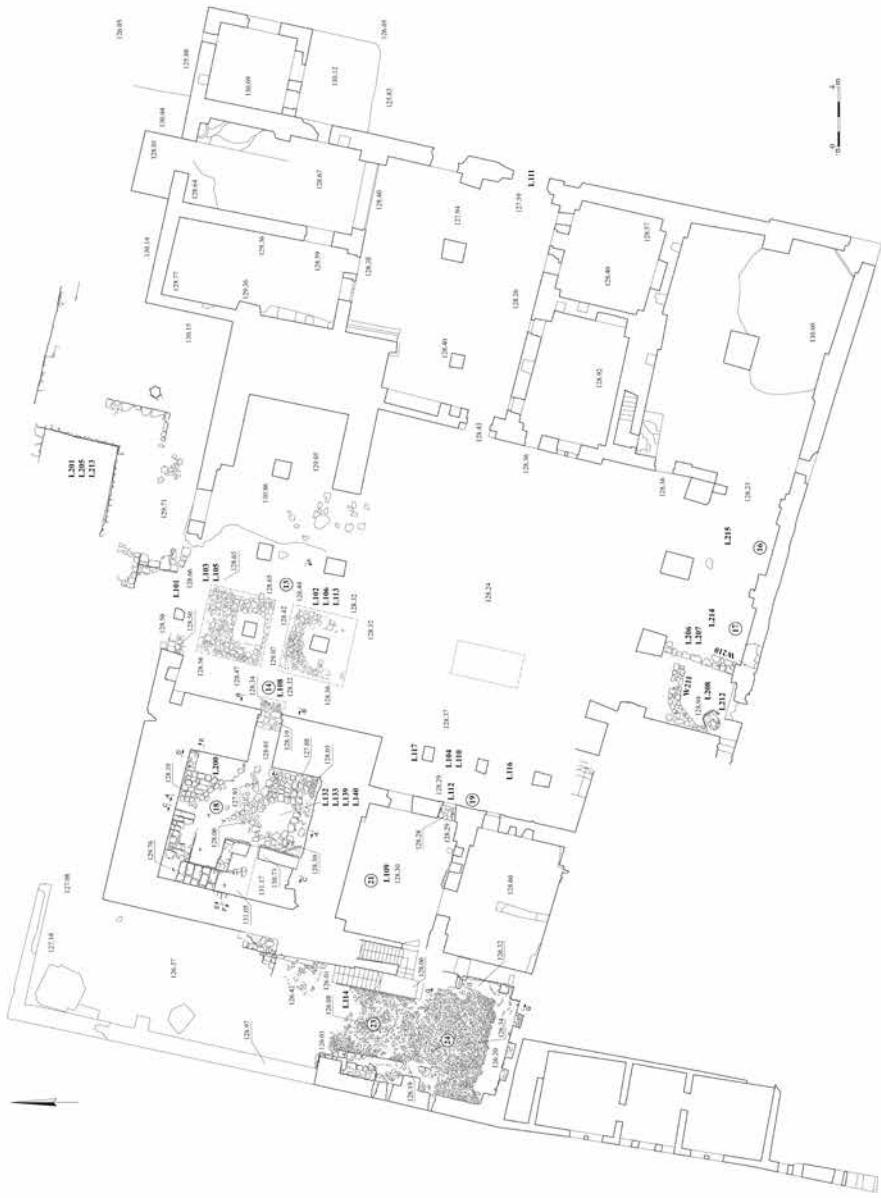
Plan 3 The excavation areas at the northwestern part of the manor house, ground floor.
