**Majdal Yābā:
The History and Material Culture of a Fortified Village in
Late Ottoman- and British Mandate-Palestine**

Tsvika Tsuk,¹ Iosi Bordowicz¹ and Itamar Taxel²

ONLINE SUPPLEMENT FIGURES

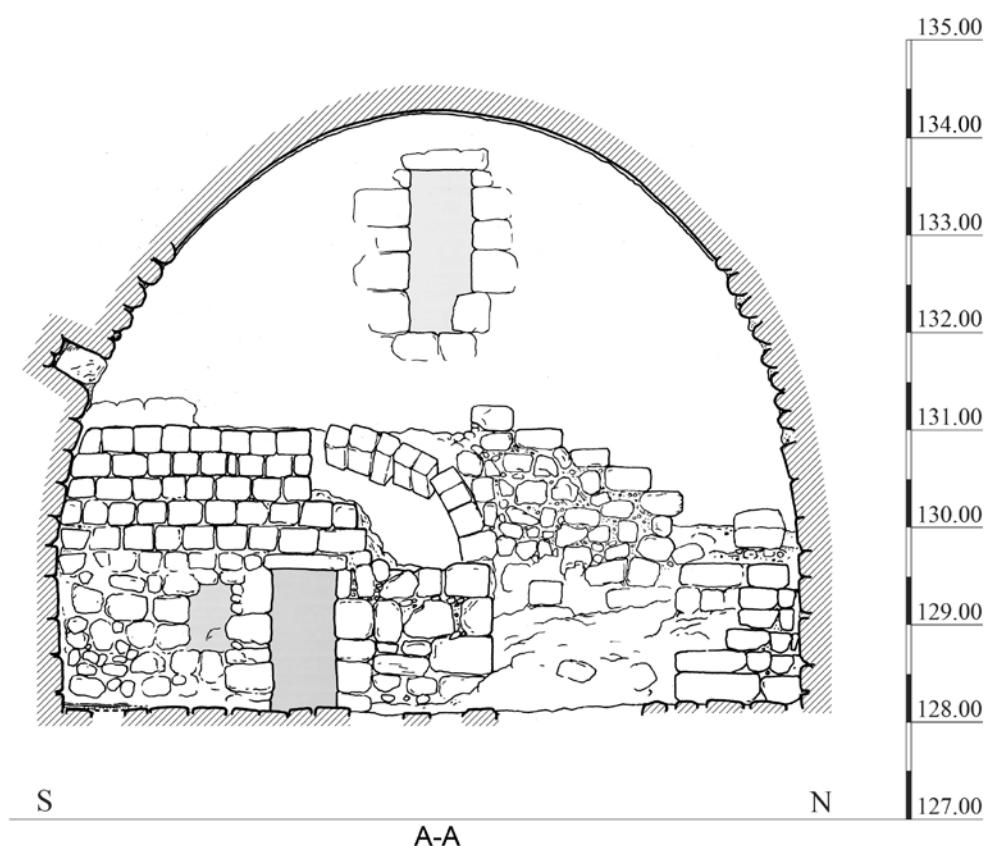
Section A-A Room 18, looking west.

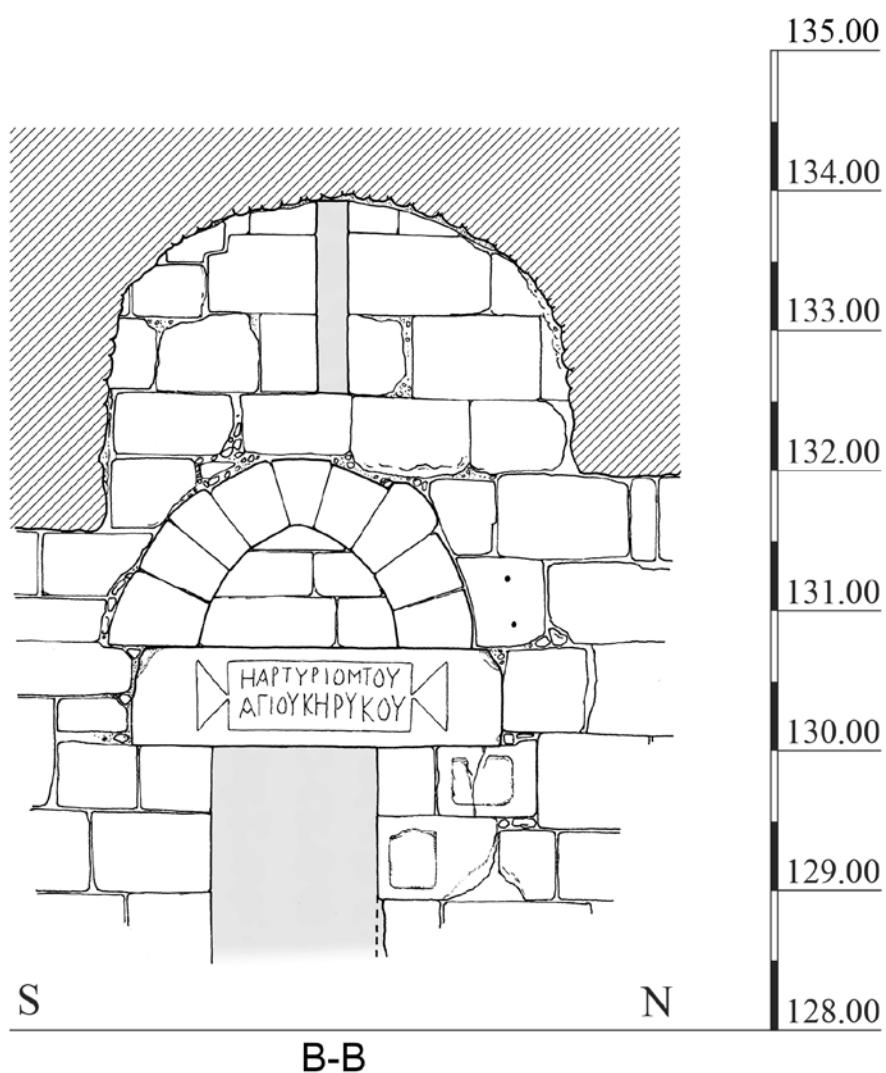
Section B-B The doorway of Room 18.

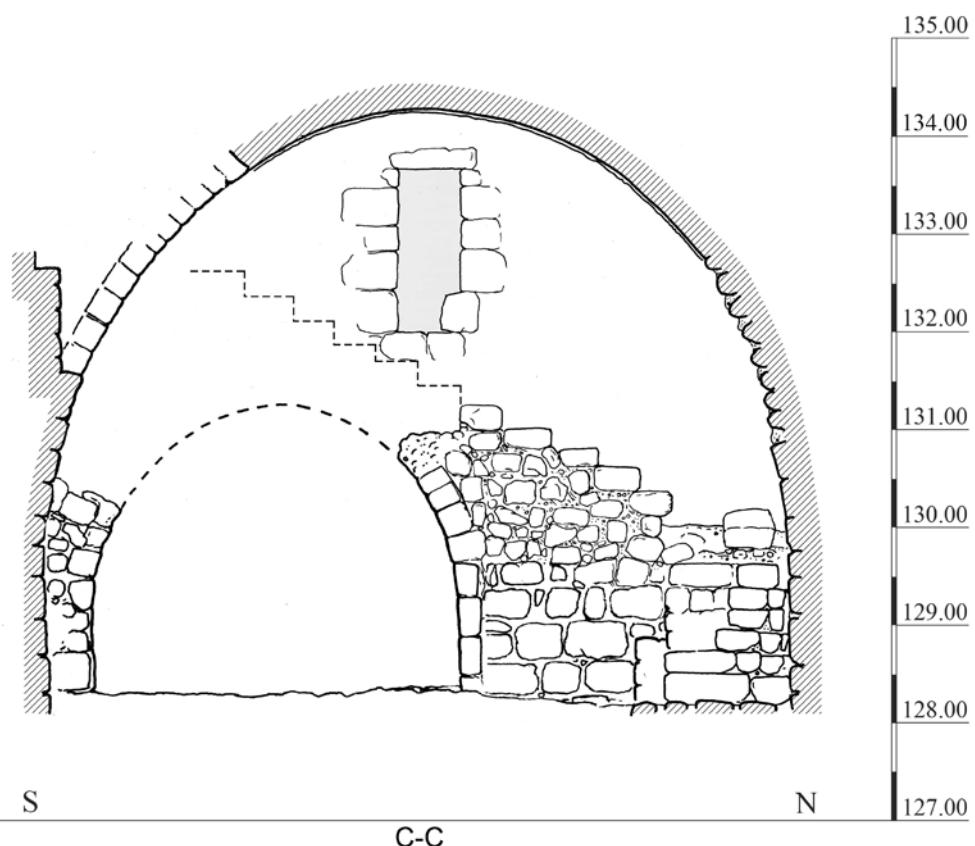
Section C-C Room 18, looking west, with reconstructed line of staircase.

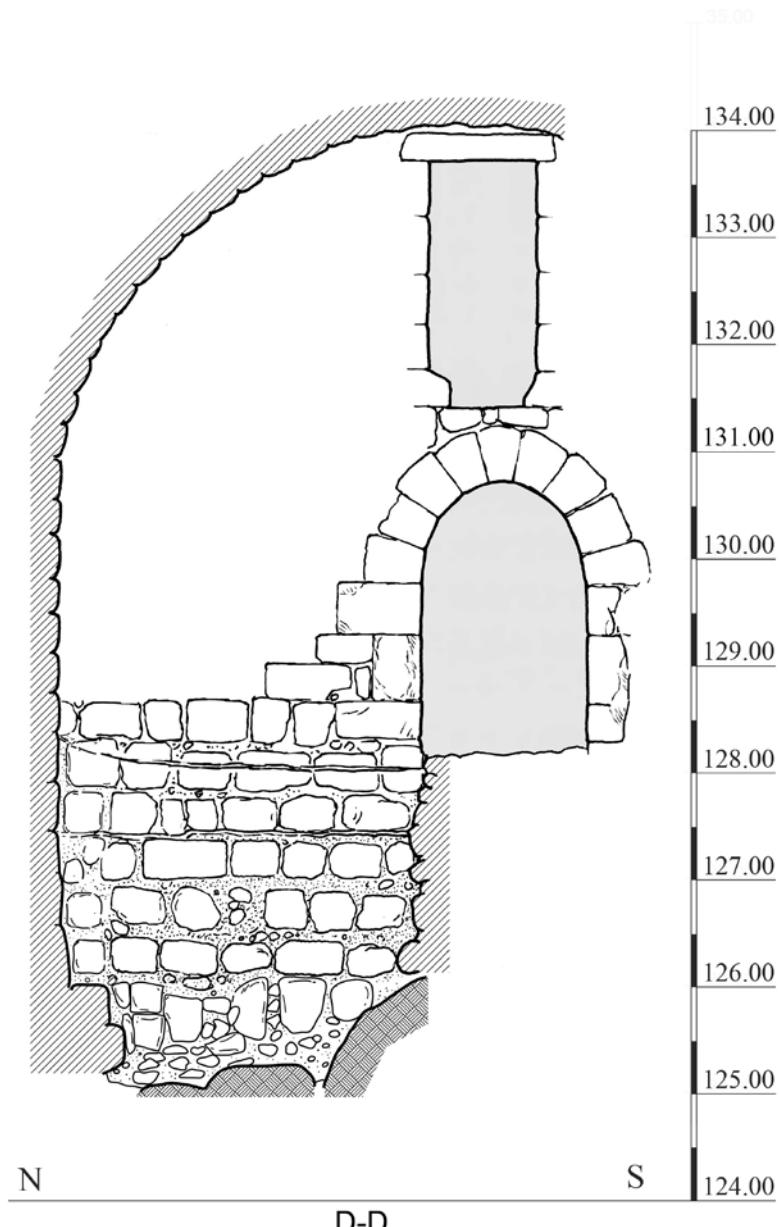
Section D-D Room 18, looking east through Locus 200 on the northeastern corner. Note the lines of two plaster floors, from the Crusader and Ottoman periods, on the rear wall.

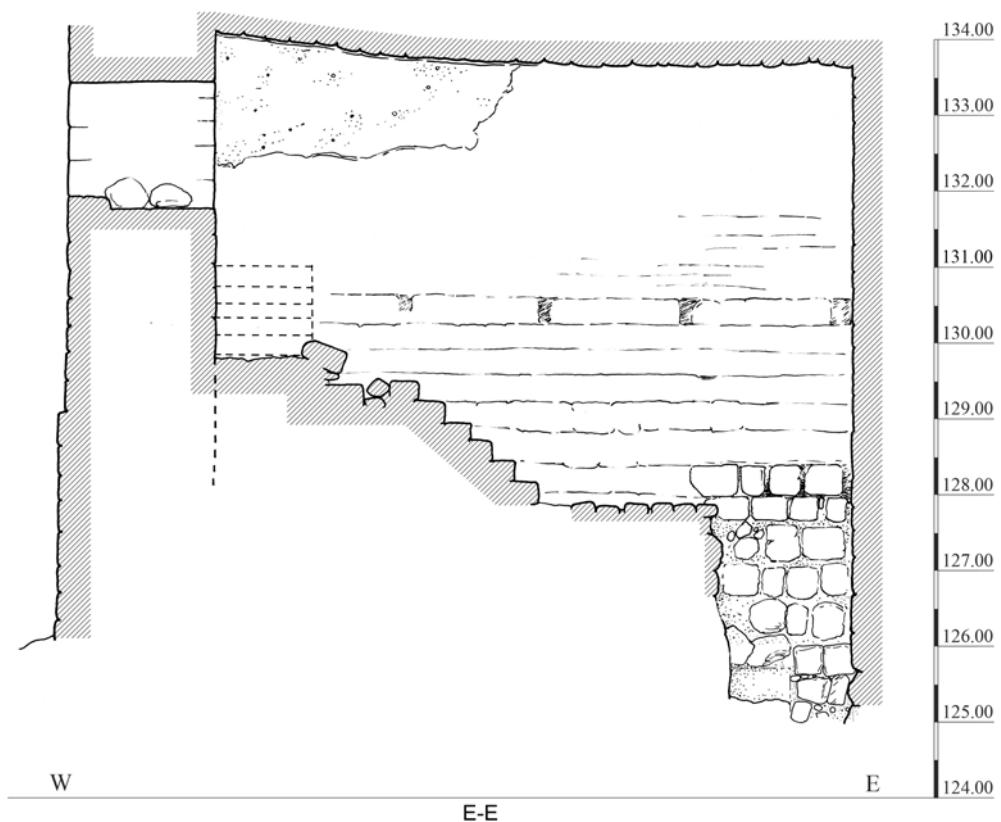
Section E-E Room 18, looking north, with probe Locus 200 on the right.

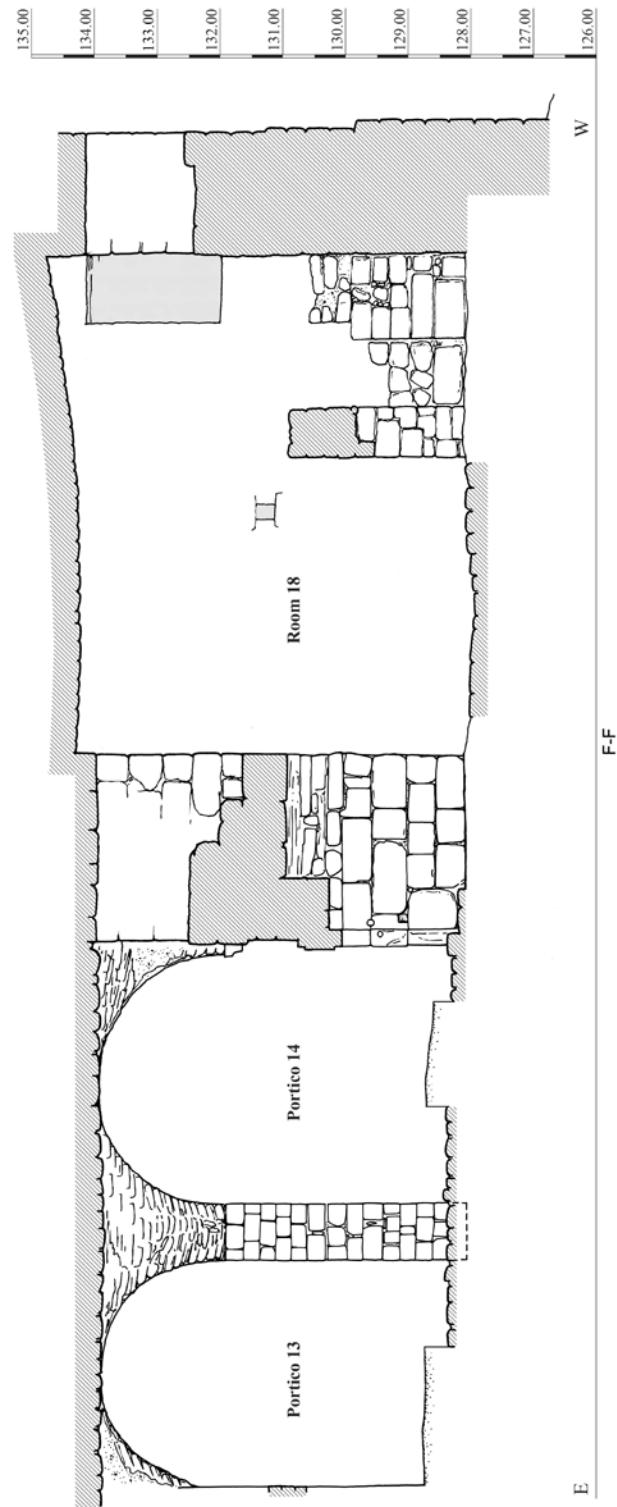
Section F-F Porticos 13-14 and Room 18, looking south.

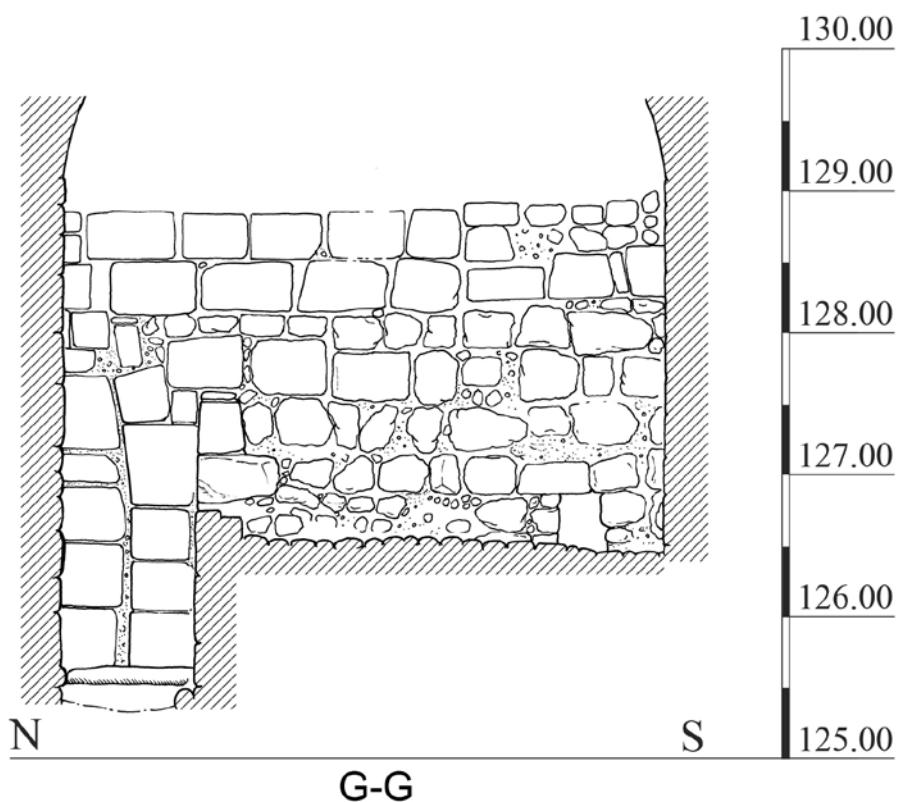
Section G-G Room 24, looking east, with blocked Crusader doorway on the left.

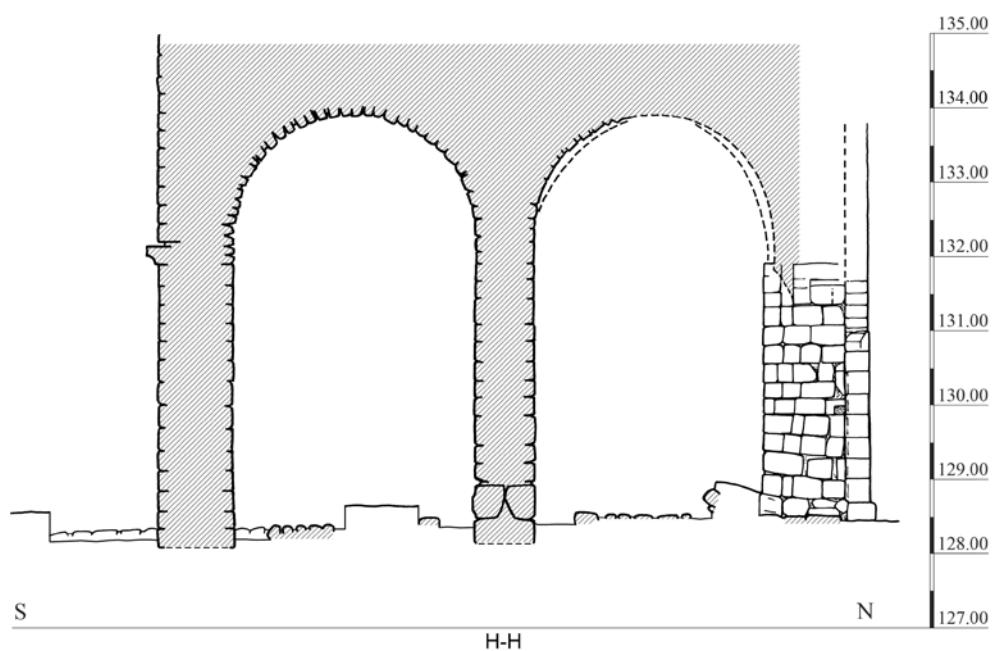
Section H-H Portico 14, looking west.
